Cranston Material Handling Equipment Co

**Rack Inspection Photos
Documenting Issues Found**

Prepared for
Acme Anvil Associates
100 Wyle Coyote Way
Surprise, Arizona 85374

On-site Contact: R. Runner
Date of Inspection: 08/08/2020
Inspected By: Ben Wadlow

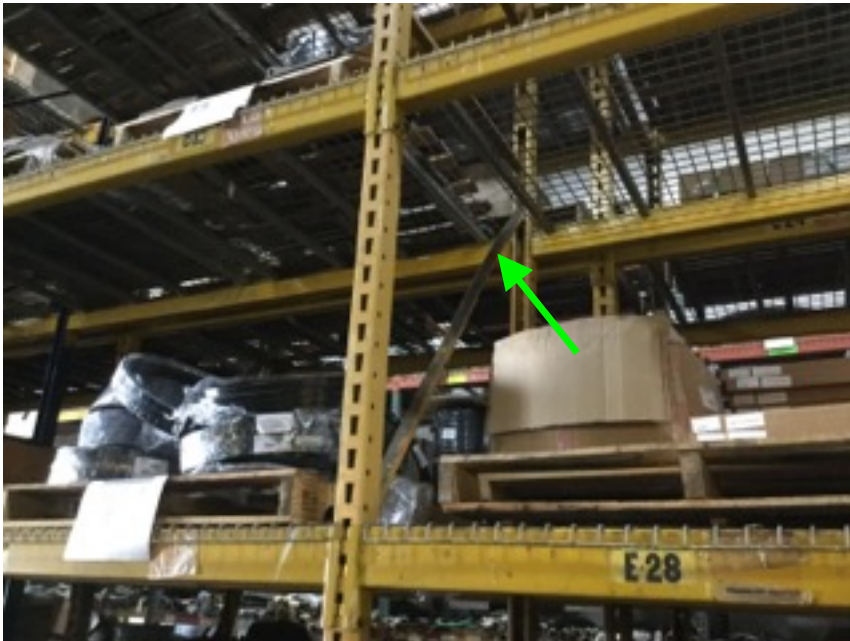
31Q-R & Middle

- **Right bracing damaged**

Upright

Issue To Be Addressed

- Right bracing damaged
Right side, middle diagonal

Bracing should be repaired or the upright replaced.

- Bracing repair kits manufactured by Damotech, MacRak, or Worldwide Material Handling can be used to repair/replace the damaged braces.

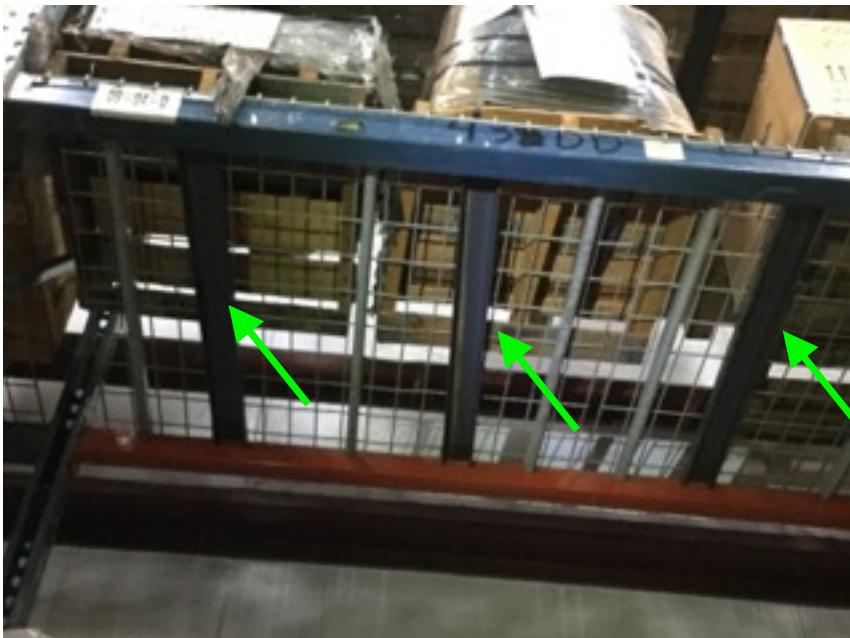
32BB to 32GG all Levels

- **Not tek screwed to beam**

Pallet Support

Issue To Be Addressed

- Not tec screwed to beam

Pallet supports are not teked to the beams, as per manufacturer's recommendations. Install Tek screws to secure pallet supports to beams.

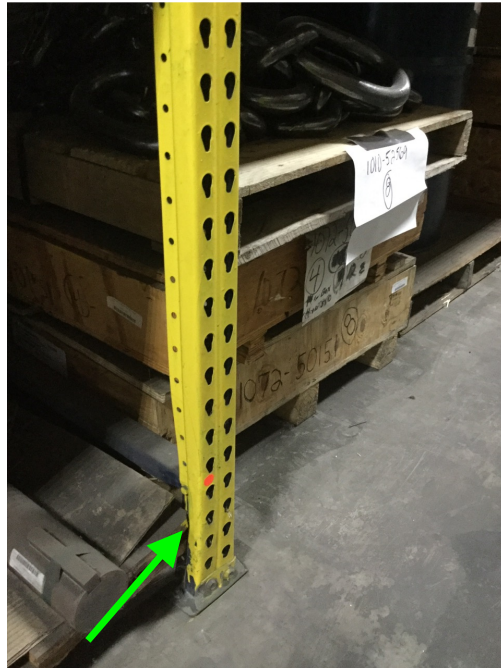
32L-L Back column

- **Left column kinked**

Upright

Issue To Be Addressed

• Left column kinked
Back of upright

Upright columns kinked should be repaired or the upright replaced. Upright repair kits manufactured by Damotech, MacRak, or Worldwide Material Handling can be used to repair damaged uprights.

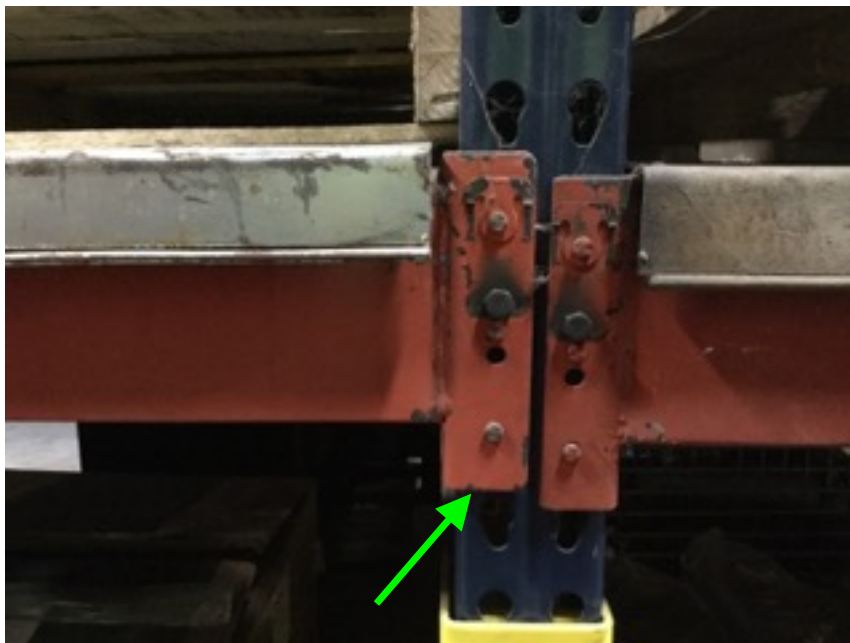
33BB-3-R

• Studs Not Engaged In Upright

Note: While the beam's safety clips help to keep beams from being dislodged, the only way to keep this dangerous situation from occurring again is to use a nut & bolt to secure every beam to the upright. Beams are dislocated by the pallet of material below the beam being raised and hitting the beam above it.

Beam Clip

Address Immediately

Immediately remove all material on the beam level and if the beam is studs are not damaged reinstall the beam so the beam studs are properly seated down into the holes in the face of the upright. If the safety clip is missing, install a bolt & nut or a J-pin. Facility personnel were made aware of this highly dangerous situation, so corrective measures could be taken immediately.

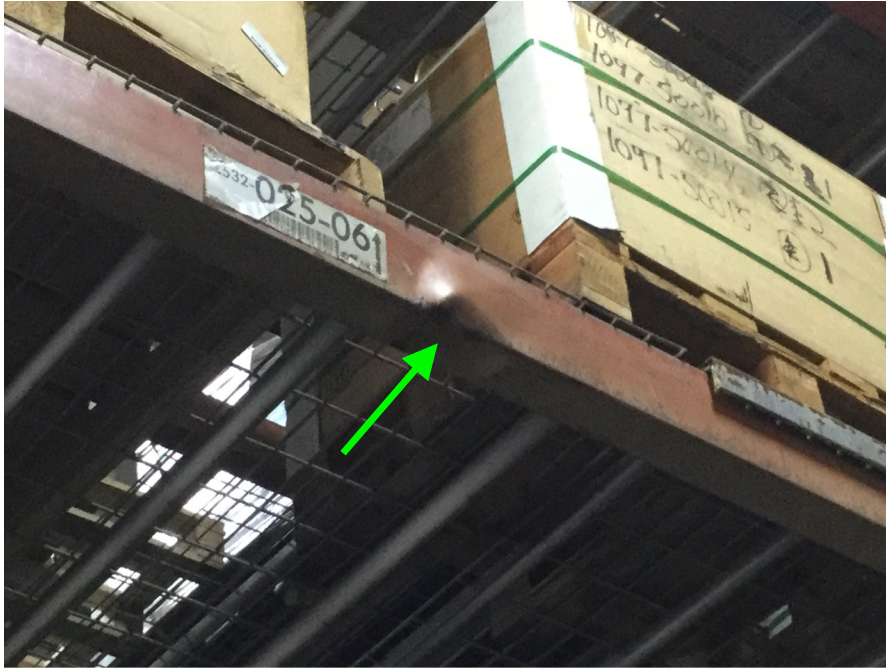
33G-6-C

Beam**• Bent**

Beam

Minor Issue

• Bent

Replace all beams that are color-coded as red or orange, as they are kinked and the capacity of the beam has been compromised. Yellow coded beams have slight denting.

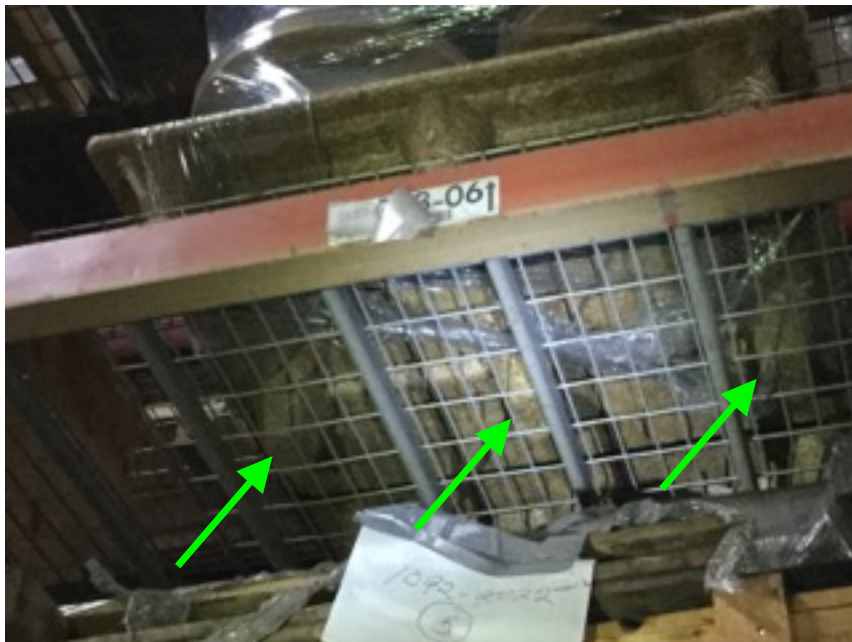
33N-7-C

- **Point Loading**

A point load is created when a pallet or container has feet which transfer all of the weight of the pallet or container to a small area of the wire deck. A standard wire deck is designed to support a uniform distributed load and not a concentrated load which can damage or cause the wire deck to fail.

Wire Deck

Issue To Be Addressed

• Point Loading

Remove skids that create point loads and place them on the floor or purchase engineered decks designed to support point loads, such as Ohio Gratings' PressLock decks.

See attached document describing proper wire deck loading

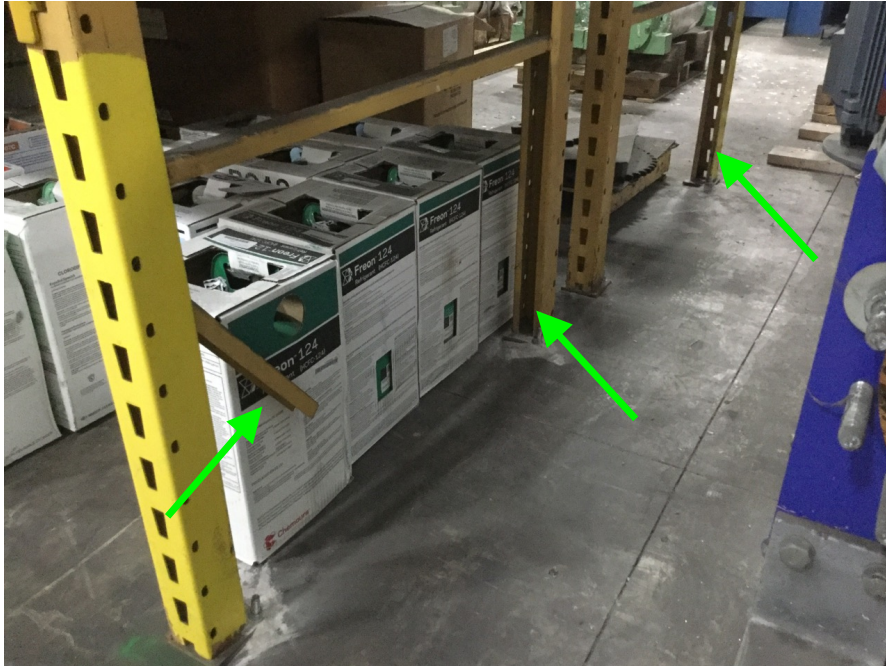
All row 34

- **First horizontal bracing is missing**

Upright

Issue To Be Addressed

• First horizontal bracing is missing

Bracing should be replaced.

- Bracing repair kits manufactured by Damotech, MacRak, or Worldwide Material Handling can be used to repair/replace the damaged braces.

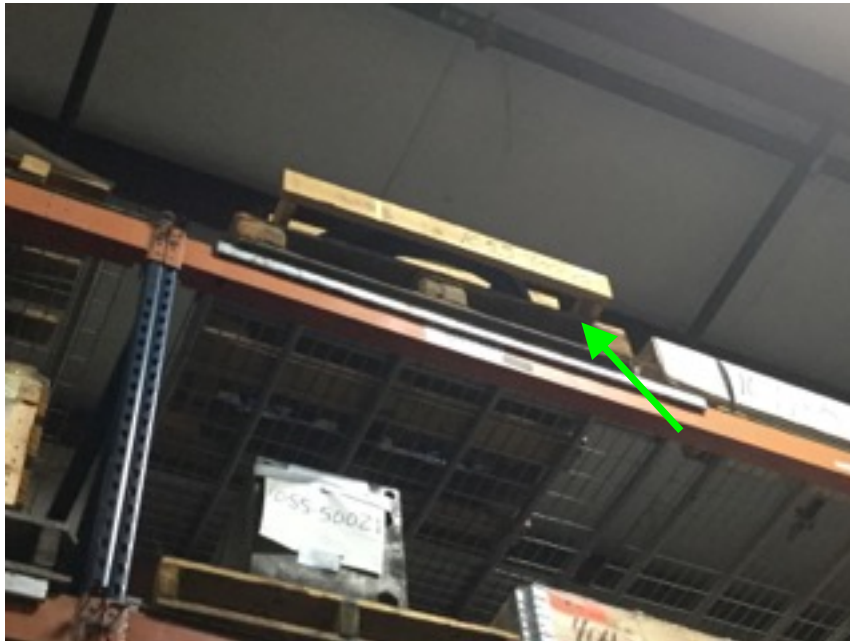
50G-6-L

- **Pallet or Material Extends More Than 5" Beyond Front of Beam**

Pallet Loading

Issue To Be Addressed

• Pallet or Material Extends More Than 5" Beyond

Train warehouse personnel to correctly place pallets on the rack. Pallets should be positioned so the pallet overhangs both the front and back beams by about 3". Pallets that extend beyond 4" in front of the rack beam create a potential hazard for the forklift operator who is loading pallets on beam levels below or above the pallet that is sticking out too far. The load they are lifting may hit this pallet causing an accident. Also, when the front left to right board on the bottom of the pallet sits in front of the front beam the majority of the weight of the pallet is now supported by the center left to right bottom boards of the pallet, which causes damage to and bending of the wire decks.

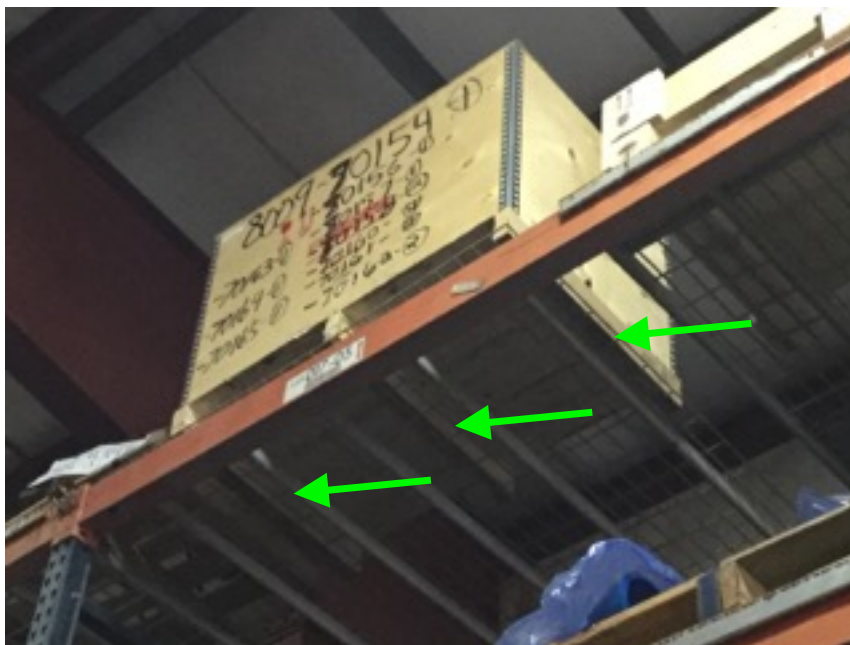
50N-5-L

- **Line Loading**

A line load is created when a crate, container, or skid's bottom runner boards do not sit on top of both the front and back beams or the wire deck's channels but rather sit on and are primarily supported only by the wire. A standard wire deck is designed support a uniform distributed load and not a concentrated load which can damage or cause the wire deck to fail.

Wire Deck

Issue To Be Addressed

• Line Loading

Remove skids that create line loads and place them on the floor or purchase engineered decks designed to support line loads, such as Ohio Gratings' PressLock decks.

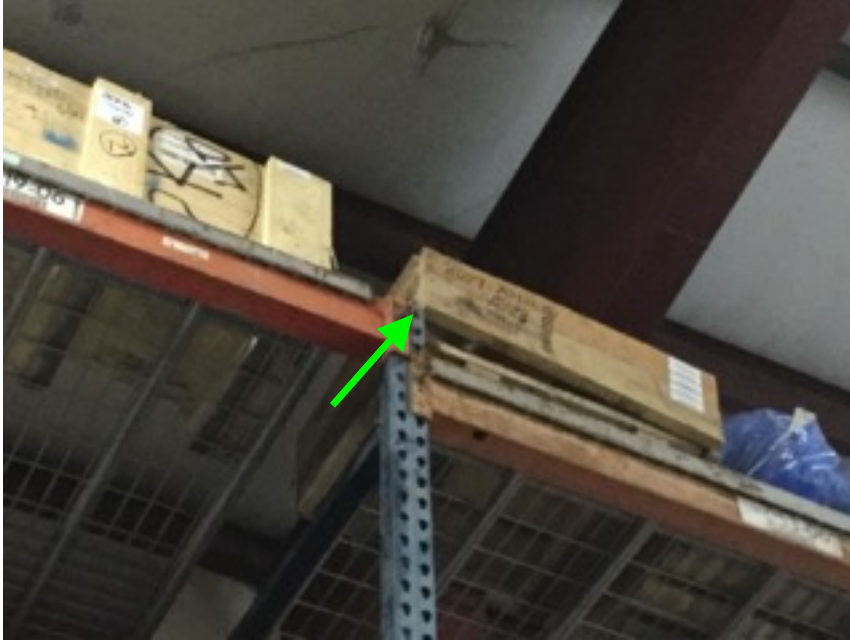
Other**• Damaged Crate with Loose Front Board**

Location	Issue	Action to be Taken	Details/Comments
50P-5-L	Other	● Issue To Be Addressed	• Damaged Crate with Loose Front Board

Remove the damaged crate and place the material in a structurally sound crate.

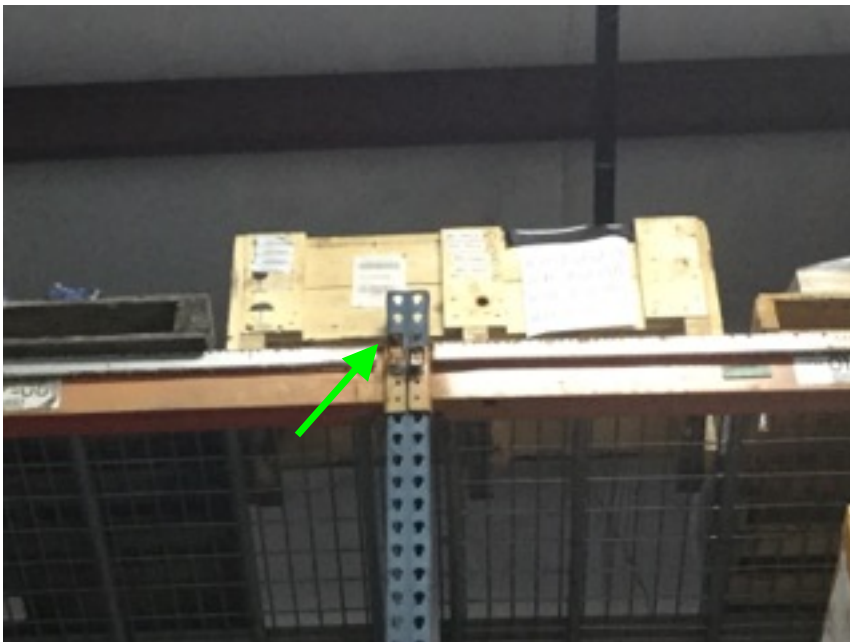
Pallet Loading**• Loaded In Unsafe Manner**

It is an unsafe practice to place a pallet on the top beam level behind an upright. The pallet can catch on the upright when it is being loaded or unloaded causing an accident.

50R-5-L	Pallet Loading	● Issue To Be Addressed	• Loaded In Unsafe Manner
---------	----------------	-------------------------	---------------------------

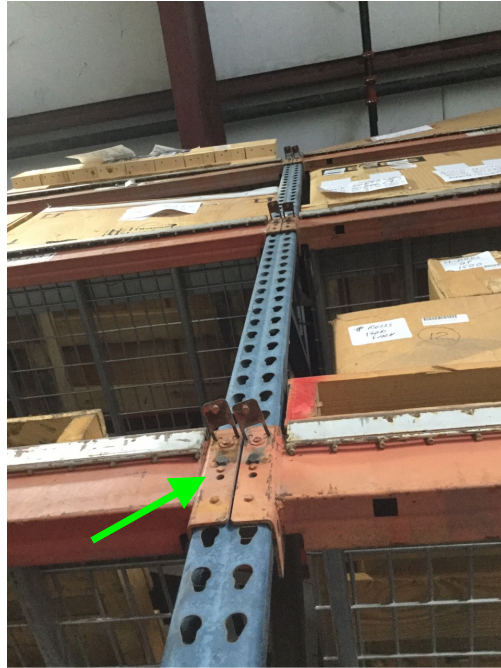
50S-3-L

Beam Clip**• Safety Spring Clip Bent**

Beam Clip

Issue To Be Addressed

• Safety Spring Clip Bent

Replace beam clips or install a nut & bolt or a J-pin to secure the beam to the upright. If a bolt or J-pin cannot be installed, replace the beam.

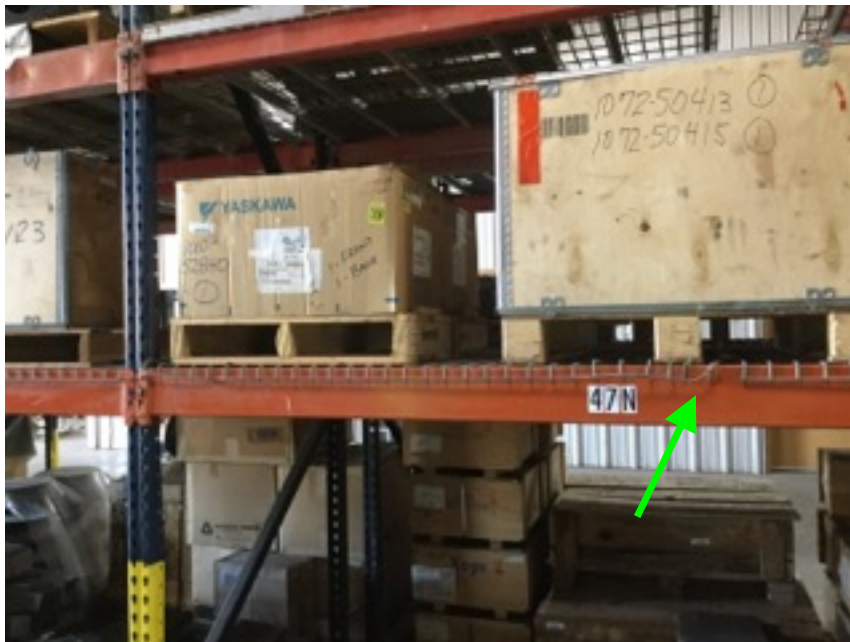
51B-2-R

- **Bent or Broken Wires**

Wire Deck

Minor Issue

• Bent or Broken Wires

Wire decks with significant bending or broken wires should be replaced.

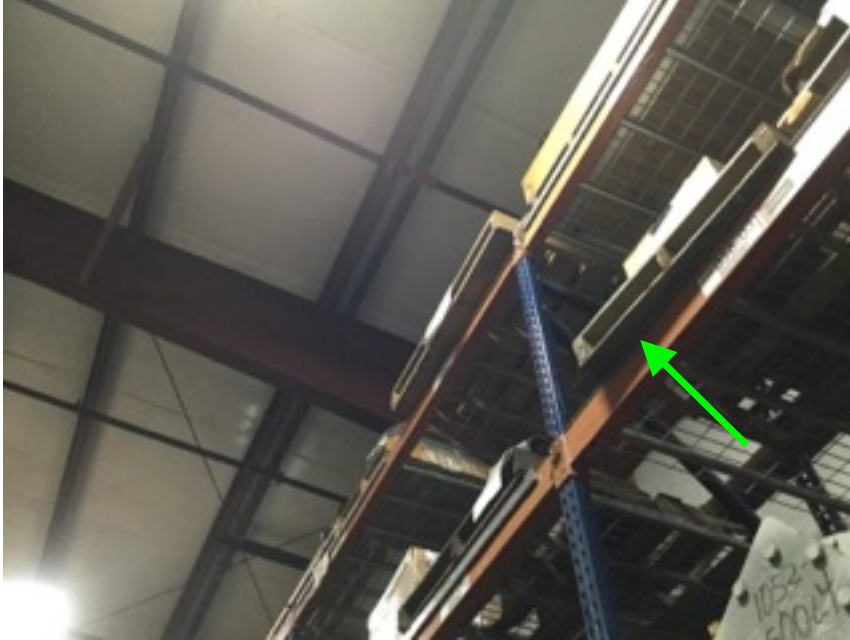
- **Pallets Not Positioned Properly on Wire Decks**

Location	Issue	Action to be Taken	Details/Comments
52D-6-R	Pallet Loading	● Issue To Be Addressed	• Pallets Not Positioned Properly on Wire Decks

Train forklift operators to always place pallets squarely on top of the wire decks with the left to right boards on the bottom of the pallet positioned over top of three or more of the wire deck's front to back channels. This will allow the pallet load to be uniformly distributed on the wire decks.
